Identification of Changes in Irregularities for a Modernized Railway Track

Julian Kominowski, Bogdan Sowiński
Poznan University of Technology, Poland

This article describes the analysis of measurements of track irregularities for a selected section of a modernized railway track. The paper presents changes of selected irregularities resulting from the traffic load levels on the track section. The authors focused on analysing results of track geometry measurements and analysing waves of track lateral and vertical irregularities. Measurements of track irregularities were performed at the same track section by indirect and direct methods.

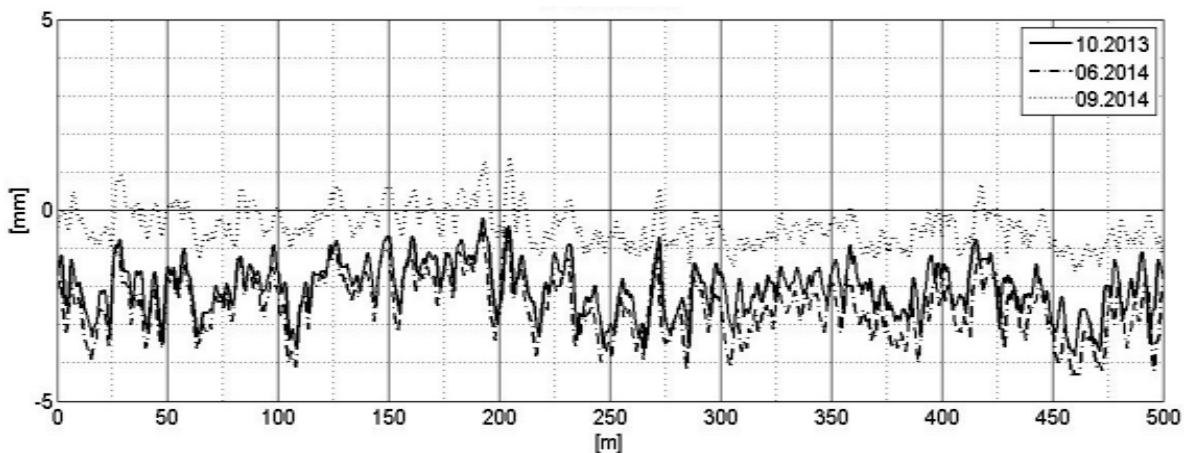
Fig. 1. The width of the track at the selected section, measured with the direct method in various periods of exploitation.

Measurements presented in Figure number 1 reveal “similar” courses of irregularities as well as progressive narrowing of the track being the result of the traffic load. After conducted corrective measures, a considerable enhancement is visible with regard to the width of the track. In case of measurements conducted by means of the measurement trolley, also a progressive narrowing has been observed, however, measurements conducted in such manner do not provide information on a considerable improvement regarding the width of the track as in case of measurements conducted by means of the track

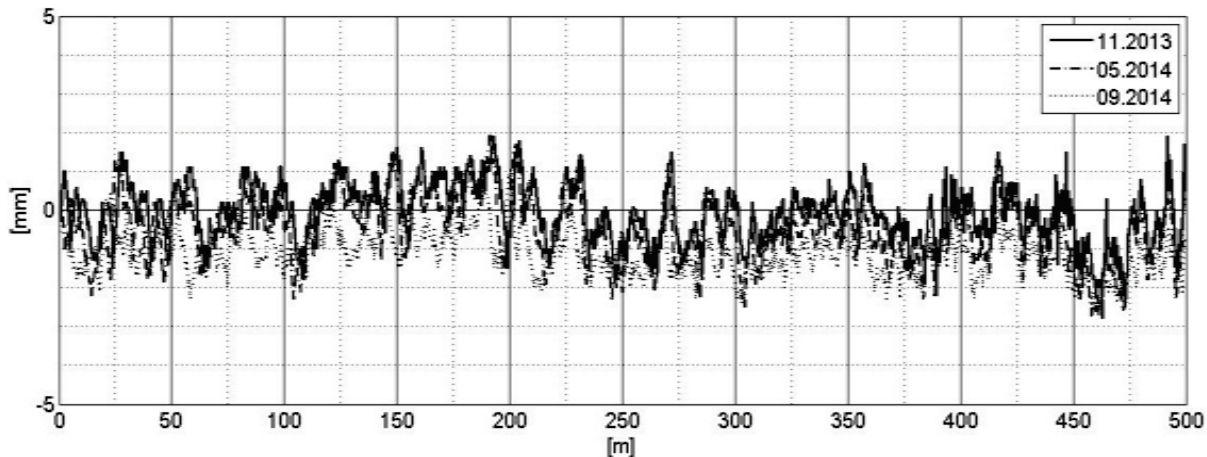
gauge. The third measurement conducted with the indirect method after corrective measures revealed a number of point narrowings.

Fig. 2. The width of the track at the selected section, measured with the measurement trolley in various periods of exploitation.

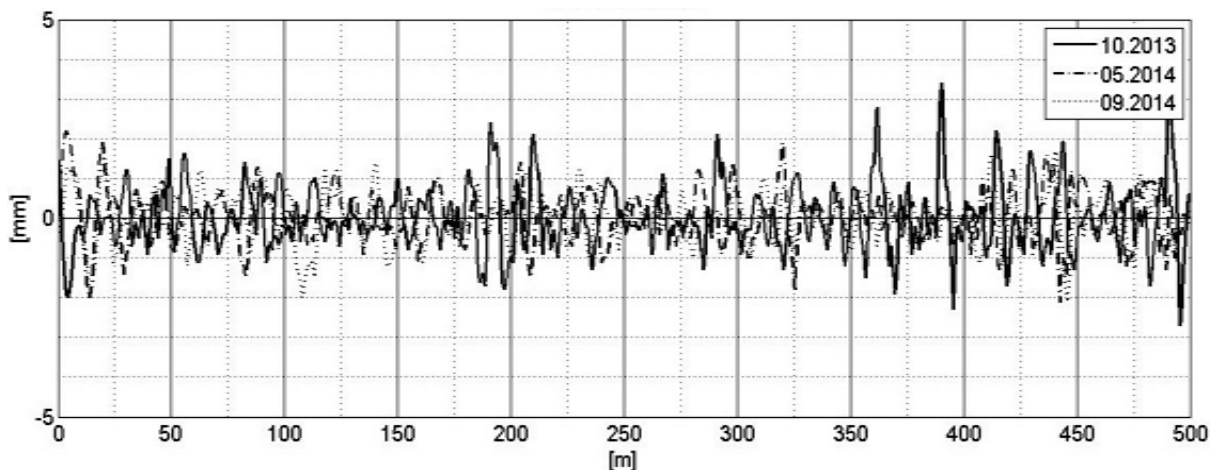
Fig. 3. The twist of the track at the selected section measured with the direct method in various periods of exploitation.

Measurements of track twists using the track measuring trolley in each case indicated irregularities of similar shape. Measured track twist in each measurement was within allowed limits of deviation. The highest increases of the amplitude were noticed during first measurements, which might be resulting from the fact that these measurements were performed prior to the acceptance and due to the related contamination of the railheads occurring during the production or construction processes.

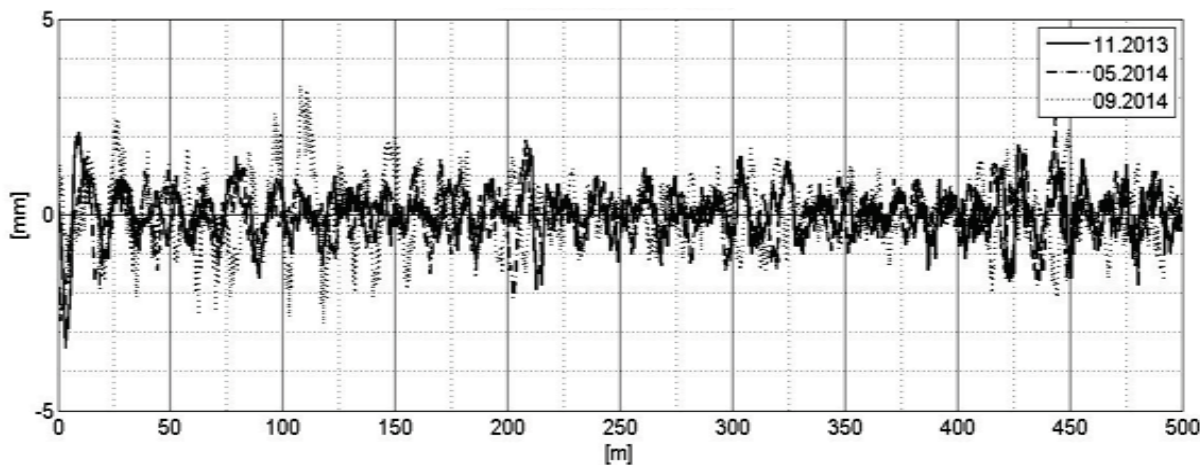
Fig. 4. Track twists at the selected section measured using indirect method in various periods of exploitation.

Intermediate measurements of the track twists (figure 4) indicate that deviation limits (5 mm [11]) for performer measurements have not been exceeded. After conducted repair works (09.2014) the measurements indicated slight increase of the track twists amplitude.

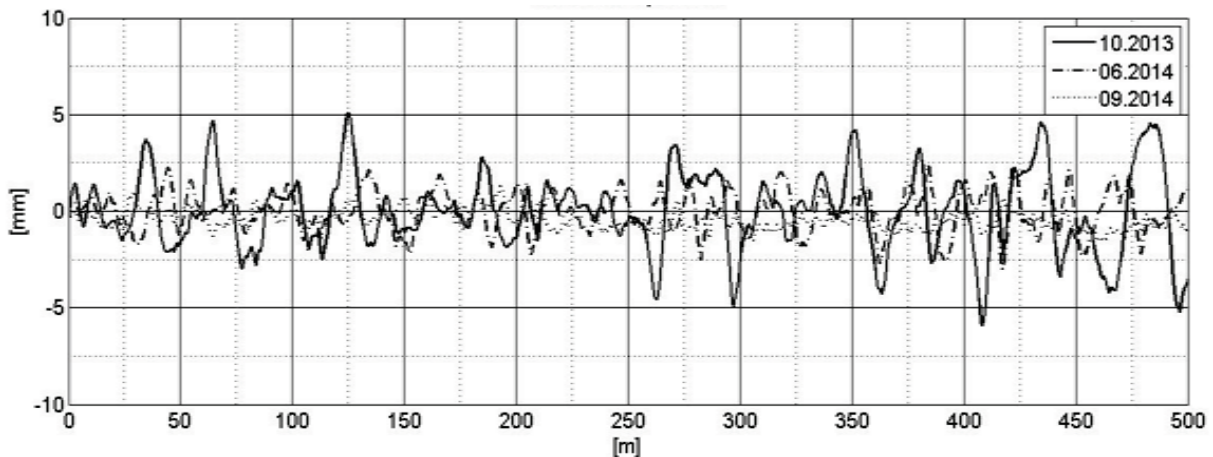
During the first measurement with the use of the trolley track gauge, high amplitudes were noticed. That might be related to the state of track prior to commissioning. Likewise in case of track twists, it can be assumed that such high amplitudes are resulting from surface contamination created at the construction site, during transport or production or from slight dynamic loads. The second measurement also revealed that the allowed limits were exceeded; however, the amplitudes were smaller. Characteristics of measurements in September 2014 indicated that the allowed limits were not exceeded.

Fig. 5. Vertical irregularities of the left rail of the selected section measured with direct method in various periods of exploitation.

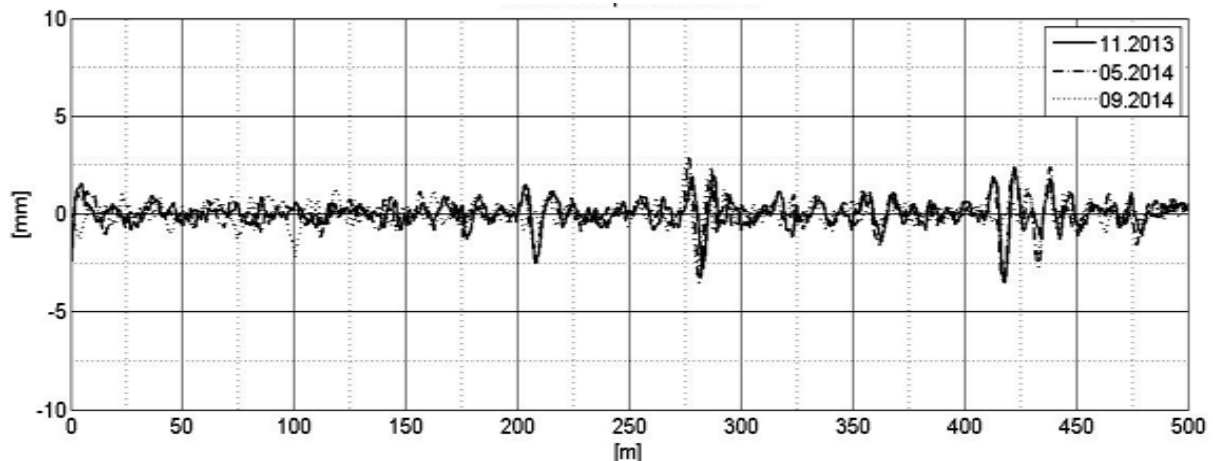
During analysis of measurements taken in relation to vertical irregularities with use of track geometry recording car at the selected section of railroad, it is possible to notice a slight decrease of the amplitude values due to the performed correction works. Measurement of the status of

Fig. 6. Vertical irregularities of the left track at the selected section measured with indirect method in various periods of exploitation.

railroad taken in November 2013 was performed on a track that was newly commissioned. In the period between measurements taken at the beginning of exploitation and after 6 months, no works influencing track geometry were performed at the selected section. All measurements clearly indicate that this value was exceeded in some points.

It is worth mentioning that the visible peaks of the vertical irregularities of the new track may result from the selected indirect measurement method, which is influenced by the dynamic impact of the vehicle in places of substructure's stiffness loss related to arc connections before rails welding. Additionally, slight shifts of measurements were also noticed at the same section, probably due to inaccurate measurement of the road by the measuring system.

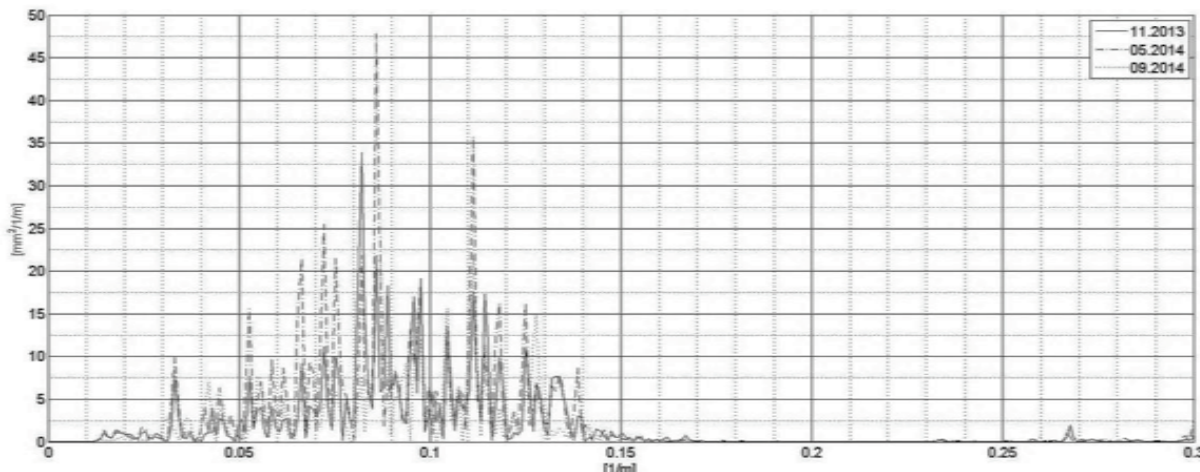
Spectral densities of vertical irregularities at the described section confirm the increase of the vertical irregularities amplitudes. Analysis of results presented in figure 7 will focus on vertical irregularities length of waves. Recorded wave

lengths of vertical irregularities are within the scope from approximately 7 m to approximately 50 m. During measurements of the tested section, two dominant waves of vertical irregularities were identified with length of approx. 9 and 12 m.

Fig. 7. Power spectral density of vertical irregularities measured with indirect method in various periods of exploitation.

Measurement taken in September 2014 shows decrease of the vertical irregularities amplitude values, which might indicate improvement of the railway infrastructure state after implemented repair works.

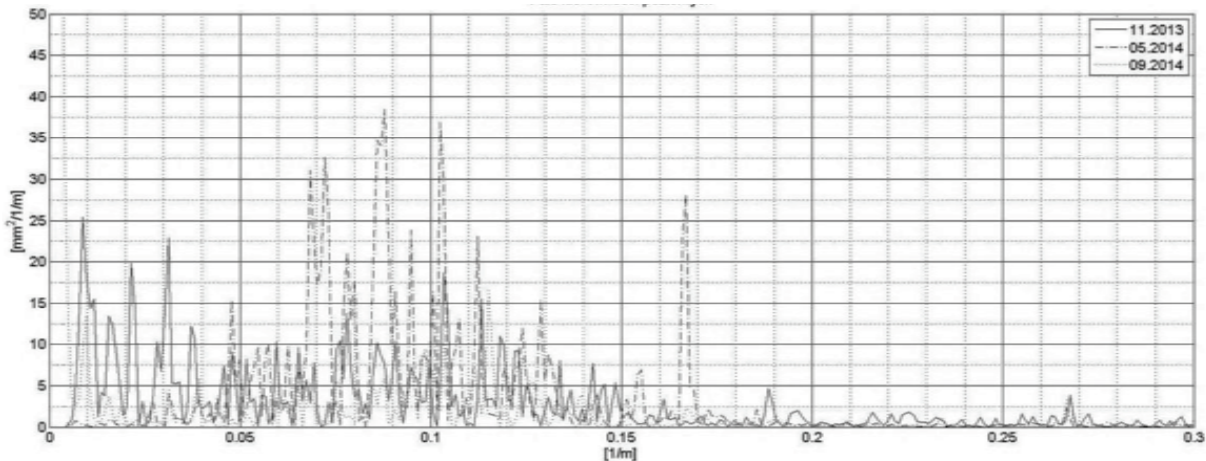
Spectral density of horizontal irregularities (figure 8) also proves the decrease of values of the horizontal irregularities amplitude. Recorder wave lengths of the horizontal irregularities are within the scope from approximately 7 m to 100 m.

Fig. 8. Power spectral density of horizontal irregularities measured with indirect method in various periods of exploitation.
