# Rehabilitation of Prestressed Concrete Bridges by FRP Composites in the Light of in Situ Testing

The article presents the analysis of FRP composite materials strengthening systems for pre-stressed bridge structure elements. Displacements and strains of main beams of bridges were investigated before and after the strengthening executed by FRP composite materials. Test load field and theoretical analysis were performed after bridge structure repair. The results of bridge structures after strengthening in field load tests allowed for an assessment of the efficiency of the strengthening, as well as establishment of guidelines for future reference concerning this type of maintenance in the engineering practice.

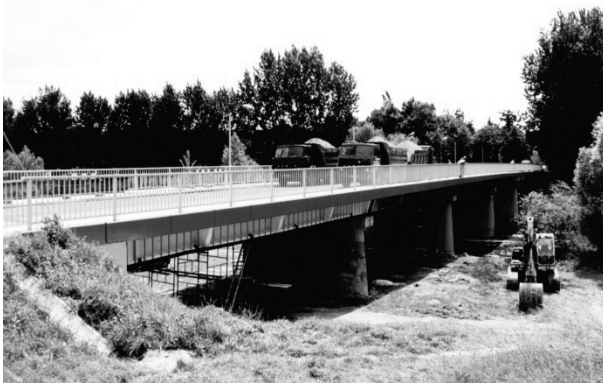
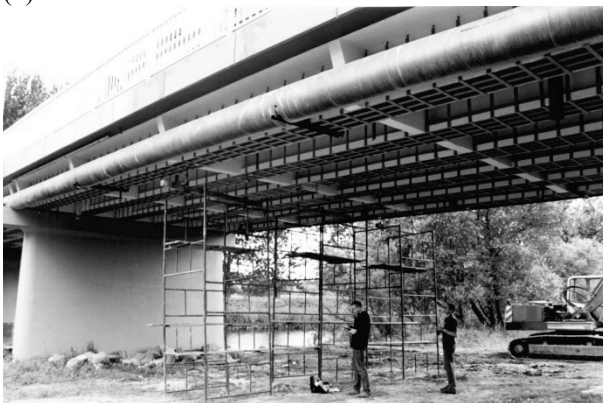
Fig. 1. General side view from the direction of the headwater of the road bridge: (a) localization of four trucks on tested span II (load scheme IIS) and (b) bottom view on the girders strengthening by CFRP strips.

The tests were carried out on the five-span road bridge. Each span consists of six main girders integrated with the new reinforced concrete deck slab of B30 ( $f_{cc} = 22.5$  MPa) concrete class. The total width of the individual spans is constant along the bridge length and it is 9.94 m (Figures 1, 2). The total length of the bridge is 98.60 m. The effective length of each of the spans is 18.00 m.

The strengthening of the particular bridge spans was accomplished by gluing the CFRP strips made of carbon fibers (three for each girder) to the bottom flanges of the main girders similar as [7]. Additionally, a new reinforced concrete deck slab of variable thickness 0.12–0.185 m was used, and also the outer stirrups in the form of steel flats of 5×50 mm section were added, with axial base by every 0.35 m [4], [5], [6], [12].

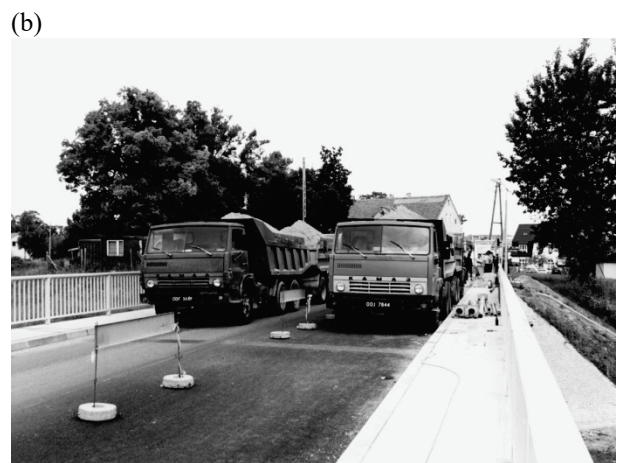
Fig. 4. Front view from Paczkow city centre on the span I loaded by: (a) two trucks (load scheme IN1) and (b) four trucks (load scheme IS) during field load tests.

The static load tests were conducted for two nonsymmetrical and one symmetrical load schemes. All the measurements specified by the test loading program were taken exclusively under a static load [6]. Four trucks of the *KAMAZ* 5511 type loaded by soil dump with the total weight of 191.50 kN, were used in the tests (Figures 3 and 4).
