# Historic Railway Spans Modernization with the Use of Modern Slab Track Surfaces, on the Example of the Wrocław Główny – Wrocław Main Railway Station Reconstruction

Grzegorz Antoniszyn

*Wrocław University of Environmental and Life Sciences, Poland*

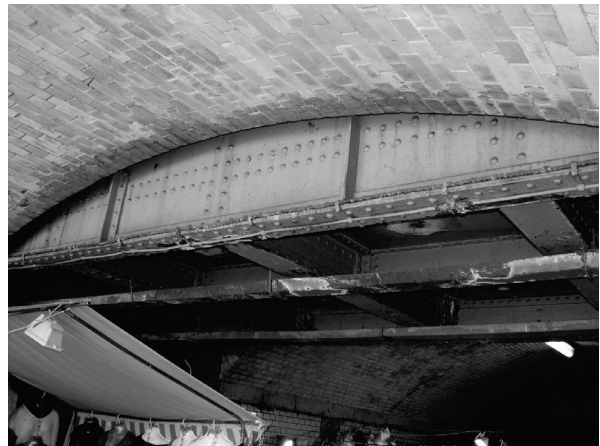
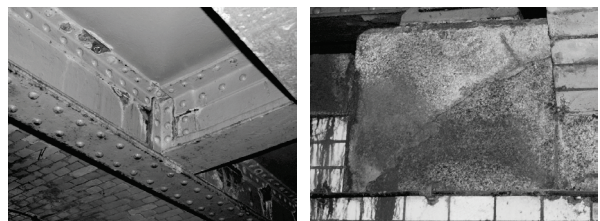
Fig. 4. Dyrekcyjna street passage: general view of the span, corrosion damage and cracking of the construction.

- intensive leaks and water fouling along with corrosion products in the nodes between the spans;
- significant loss of the top plate belts, to complete destruction, in the case of two objects;
- numerous cracks and crumbling, and even displacement of cracked fragments of stone yew;
- lack of possibility of free movement on the contact ball bearings as a result of the significant corrosion of bearing components and bearing niche contamination;
- streaks on the side walls of the tunnels, that indicated malfunction or damage to the drainage system and expansion joints.

Figures 3 and 4 show the representative damage to the engineering objects in two selected passages: the main and the management passages.

Among the listed damages to steel structures, corrosion damage is predominant. On the structural components, no damage was found to indicate that the work was inadequate or overloaded. Therefore it was decided to leave the existing spans while the stone struts and the railroad and the drainage system had to be replaced.

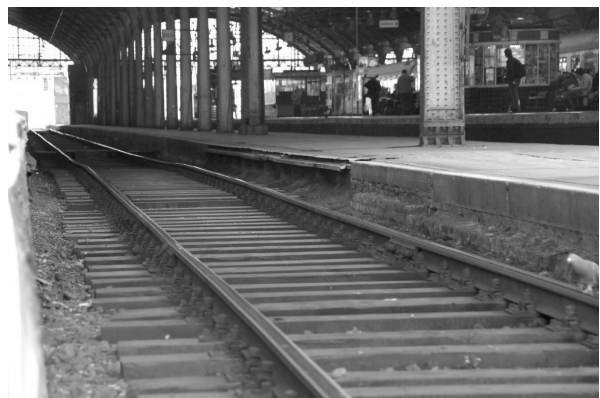
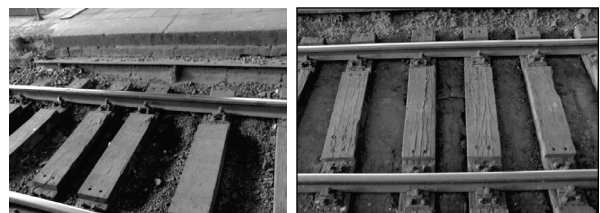
Fig. 5. Existing technical condition of the railway pavement: general view; Cross section through the span; lack of the prime of broken stone, moving undercut railway sleepers undercut and laying in wrong positions.

The technical condition of the surface of the railway was insufficient. Numerous deformations of the rails, both vertically and horizontally, collapsed in front of objects and significant pollution required immediate repair work. The surface state of the surface is shown in Fig. 5.

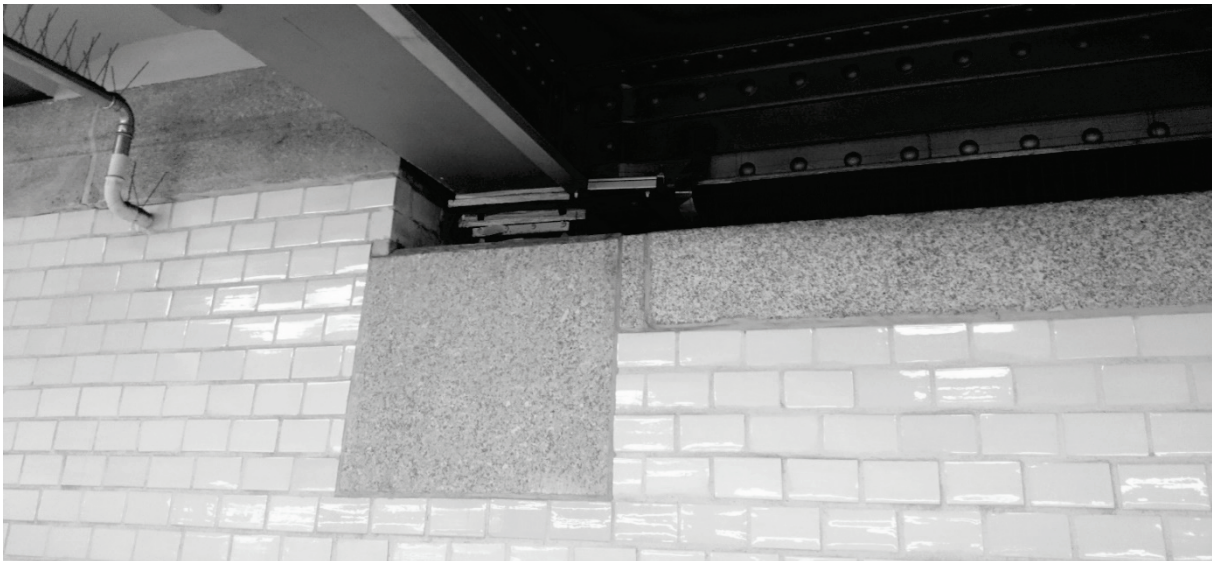
Fig. 7. Design assumptions and the final effect of lower bossages reconstruction.

Due to the numerous cracking of granite lower bossages, a decision was taken, that they should be replaced. The current legislation does not allow the use of stone elements subjected to dynamic loads, therefore it was assumed that the bossages would be exchanged for reinforced concrete slabs, with stone facings imitating granite blocks. The solution adopted and the final effect are shown in the Figure 7.

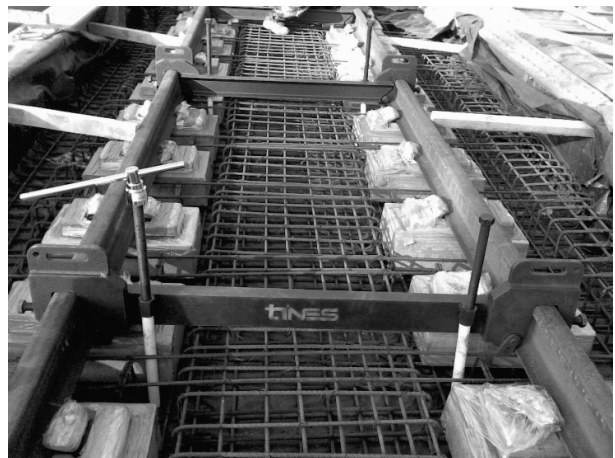
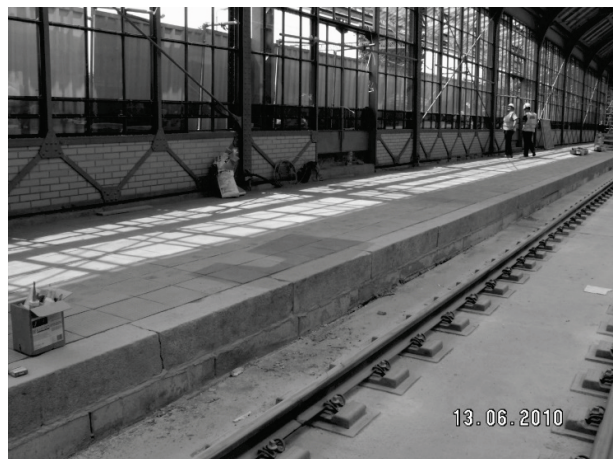
Fig. 8. Composition of EBS type pavements and stages of its construction.

The proposed slab track pavement is Edilon's Embedded Block System (EBS), a Corkelast® block embedding system [10]. The system is universal, applicable to every section of the railroad track - on a straight line, on curves with small radii and in turns. It is used in railways and underground railways (in the metro), in dedicated tramway tracks, in tunnels, on viaducts and bridges. It is characterized primarily by the high efficiency of vibration damping (vibration), caused by the motion of rail vehicles. The resilient foundation of the block supports and rails is conducive to reducing the noise level emitted from the traffic of rail vehicles, which is particularly important in urban agglomerations and in areas of large railway stations, mostly with a roof or covered in a way. Placement of the block supports,

in the resilient resinous sheath, provides further high electrical insulation of the track. The high elasticity of the rails support is conducive to the transmission of vertical and horizontal loads from the wheels, reducing the wear of the rails. This system can be used on light rail tracks and also for axle loads up to 225 kN and high-speed trains (up to 300 km / h).

Below, the components of the system and the assembly phase of blocks and reinforcement of the reinforced concrete slab (fig. 8), as well as the finished surface, are presented. Figure 9 compares the appearance of the pavement after six years of its exploitation. Currently only the soiling of the resin layer was observed, which is the result of lack of current maintenance. Visual inspection of the track design showed no signs of wear or other defects, which shows the durability of the system and the right choice, meeting the requirements set by the Investor.

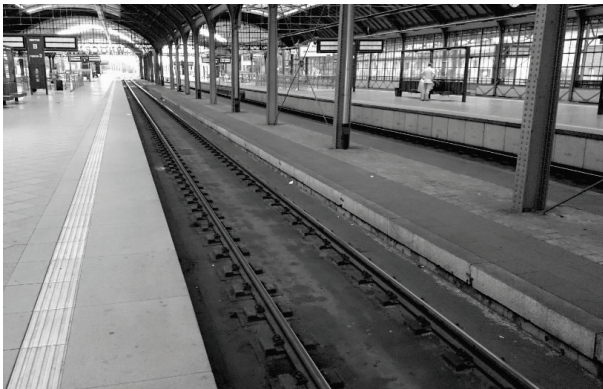
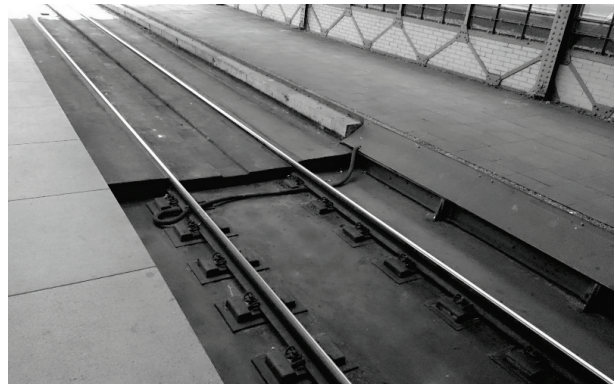
Fig. 11. Surface ERS, immediately after it has been made and six years of its exploitation.

The second kind of backfill surface, i.e. the ERS system, was used in the course of the track No. 1 over the old luggage tunnel. The change of the system was due to insufficient construction height above the ceiling of the tunnel - under the EBS blocks it was impossible to make a reinforced concrete slab of adequate thickness (at least 15 cm). Therefore, a system has been used, in which the rails are fastened in rail channels with a polyethylene terephthalate based on Edilon Corkelast® and the continuous rail support is provided by the Edilon Resilient Strip under its lower part. Due to the high adhesive strength of concrete and steel, it is unnecessary to attach the rails directly to the plate, or to the steel structure. Wet-cast reinforced concrete slab with shaped railways replaces rubble and sleepers. The ERS system provides a continuous, spring-loaded rail support, which significantly reduces noise and increases damping caused by rail travel.

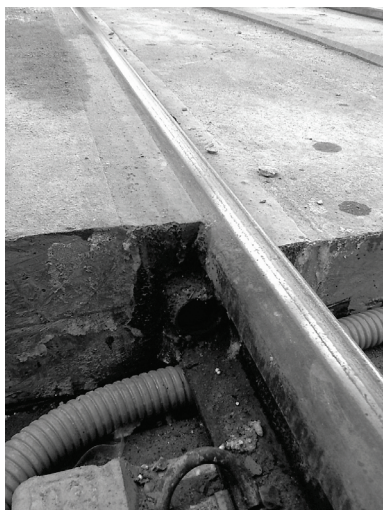
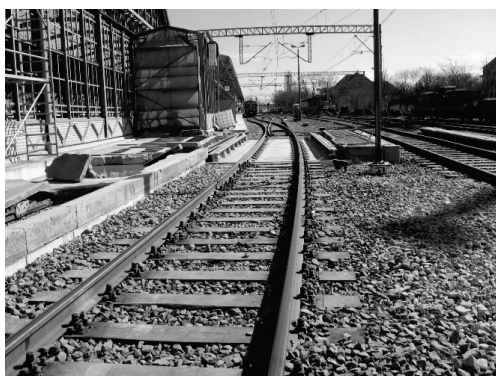
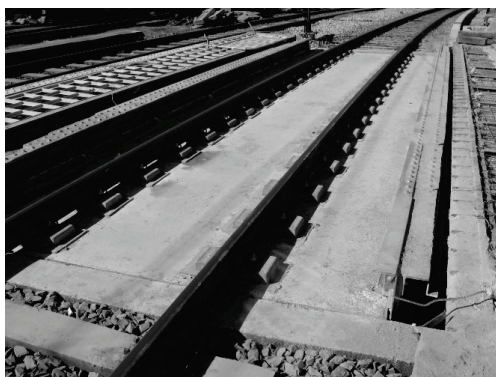
Fig. 12. Combination of pavements: slab track and classic and slab track.

The use of different types of pavement surface in the C area of the main track system, as well as the classical pavement outside of it, required the appropriate combination of pavements. The combination of the classic surface with slab track surface, required the use of transition boards. Classical solutions, known and commonly used in bridges, in the form of inclined reinforced concrete slabs (10%) were used. The combination of EBS and ERS required an expansion gap between them and an effective seal. The method of connecting the pavement is shown in Fig. 12.
